**ASSESSMENT OF VOLUME CHANGE AND MICROSTRUCTURE OF
CALCAREOUS SOILS CONTAMINATED WITH SULFURIC AND
PHOSPHORIC ACIDS**

A Thesis Presented to the
DEANSHIP OF GRADUATE STUDIES

KING FAHD UNIVERSITY OF PETROLEUM & MINERALS
DHAHRAN, SAUDI ARABIA

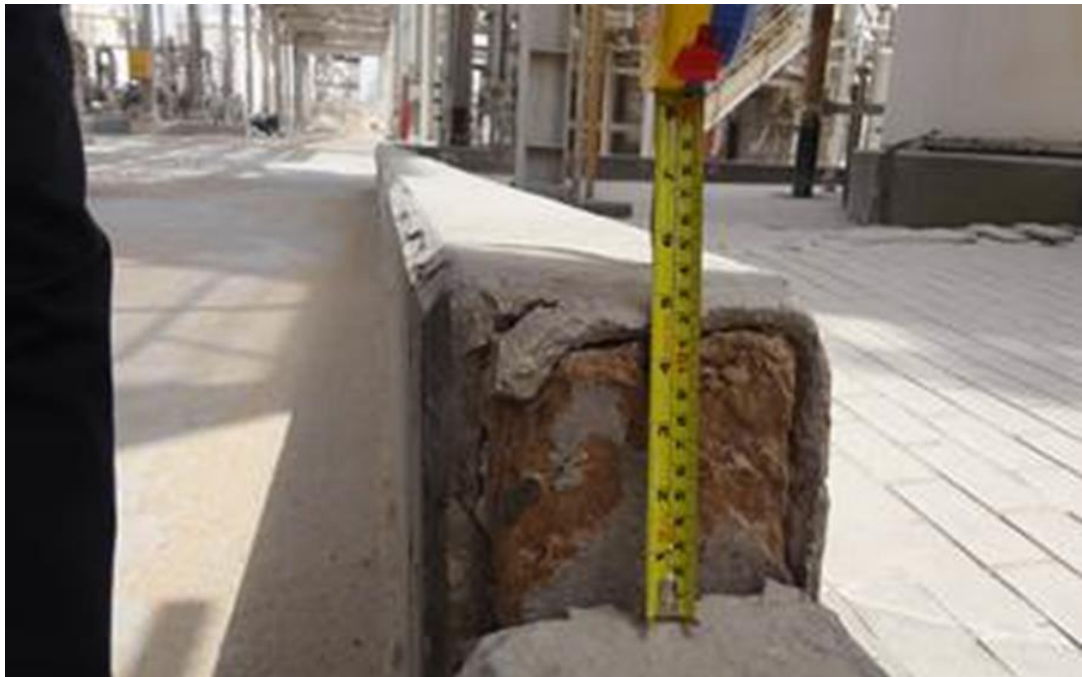
Figure 2-3: A photo showing the differential movement of tank containment wall due to acid leak and interaction with carbonate foundation soils (Aiban, 2015).

The upheaval of walkway slab and shallow containment walls of a tank can exceed 200 mm, as shown in the photograph, Figure 2.3 (Aiban, Personal communication, 2015). When the carbonate material interacts with sulfuric or phosphoric acid, it solidifies and swell, as shown in Figures 2-3 and 2-4. Such solidification reduces the permeability of the soil and most probably resulted in material's swelling or expansion leading to the upheaval of the slabs and containment walls.

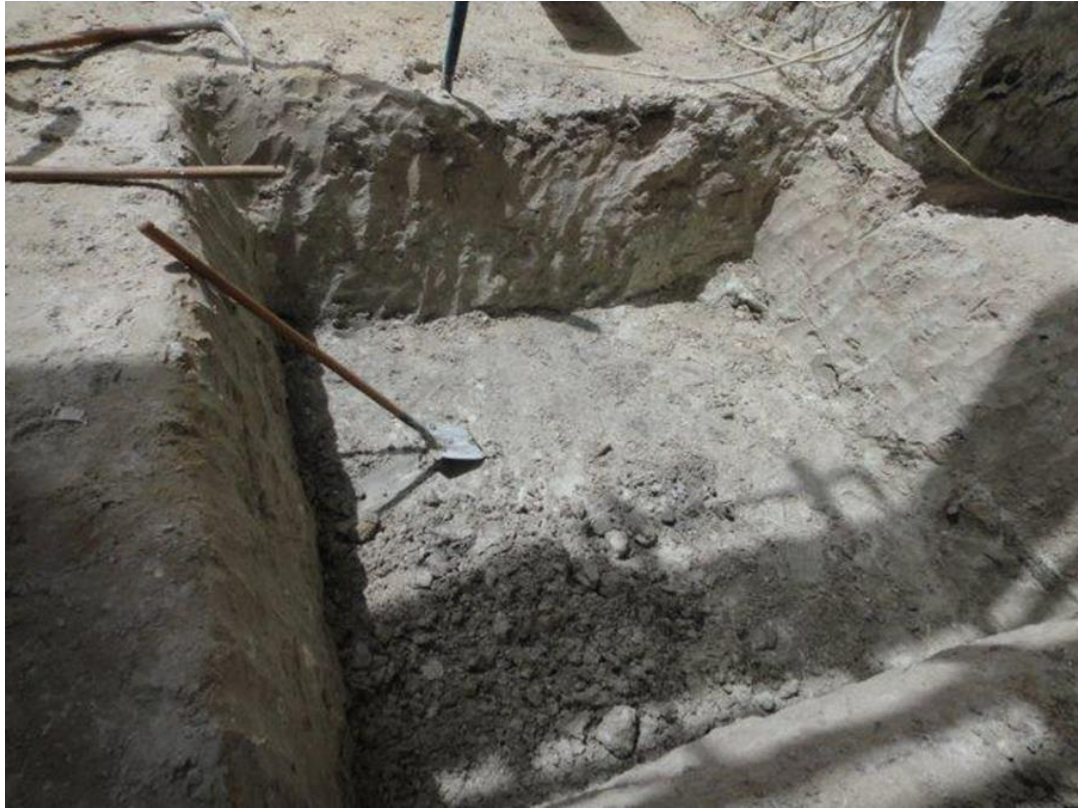
Figure 2-4: A photo showing the solidification of carbonate soils due to leakage of sulfuric/phosphoric acid (Aiban, 2015).

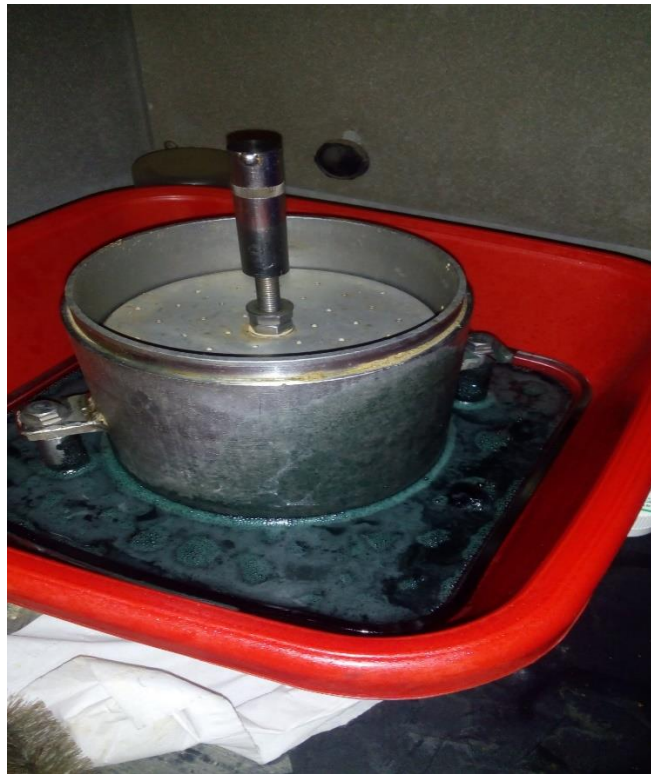
Figure 3-2: Corrosion of stainless steel mold due to sulfuric acid

Metallic molds could not be used in this experiment because the metal will not resist aggressive acids. Figure 3-2 shows the effect of sulfuric acid with 50% concentration on the stainless steel mold. The color of the acid solution was changed to dark color, which is an indication of metallic corrosion. For that, a proper sample mold, made from high-density polyethylene (HDPE) was selected for this experimental program. The mold is the end cap of pipes (Figure 3-3). The dimensions for this sample mold are shown in Figure 3-4. The mold has a length (L) of 167.5 mm, 160 mm diameter (D) and 14.6 thickness (S). However, this mold has curvature at the bottom and the length from the opening to a point before the curvature (L2) is 123.5 mm.

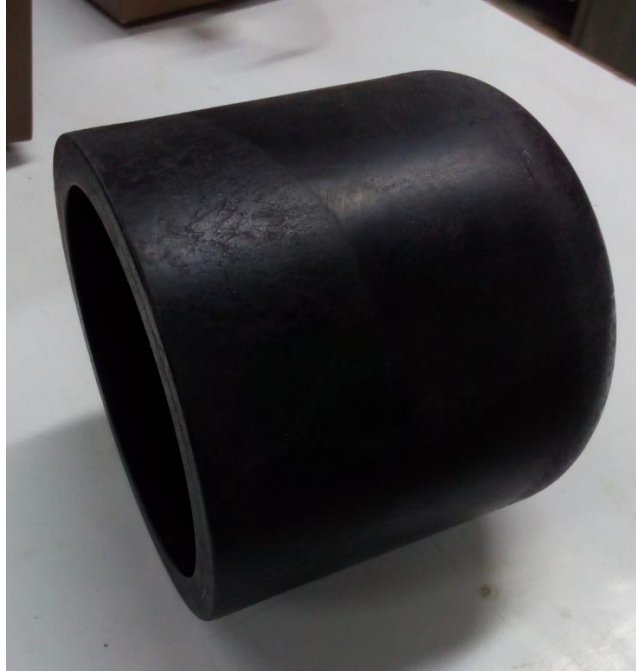
Figure 3-3: HDPE end cap used as a mold to host the samples during acid contamination

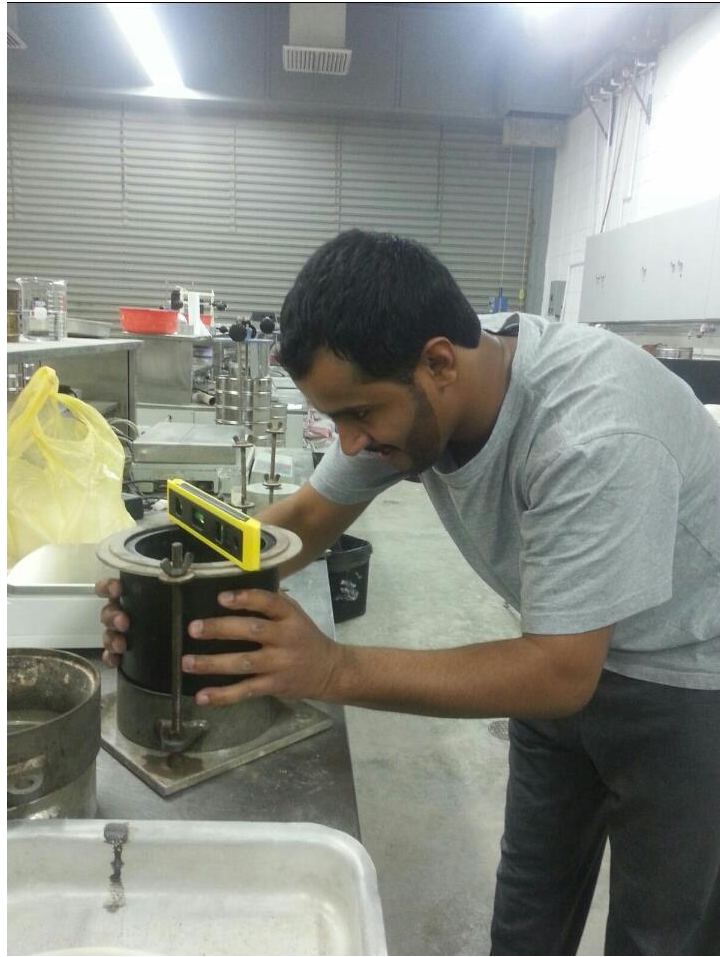
Figure 3-6: Leveling and fixing sample's mold in a CBR mold setup

- An oven-dried soil was mixed with 95% dry of optimum moisture content.
- The mold was placed on a top of a CBR mold collar and held by the collar holders after being leveled, as shown in Figure 3-6.

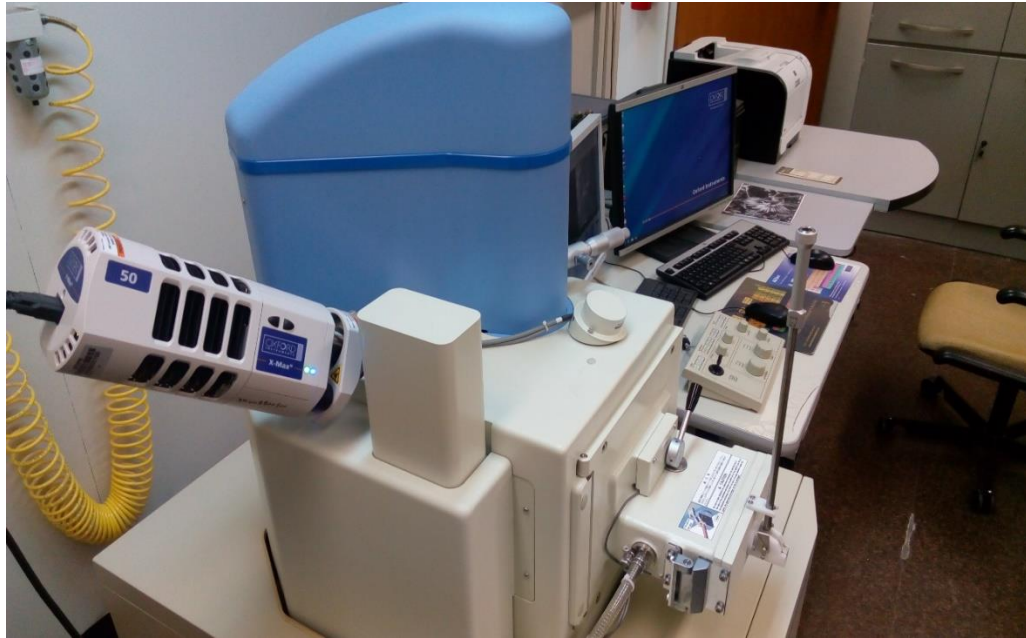
Figure 3-11: Scanning electron microscopy (SEM) model (JSM-6610LV)

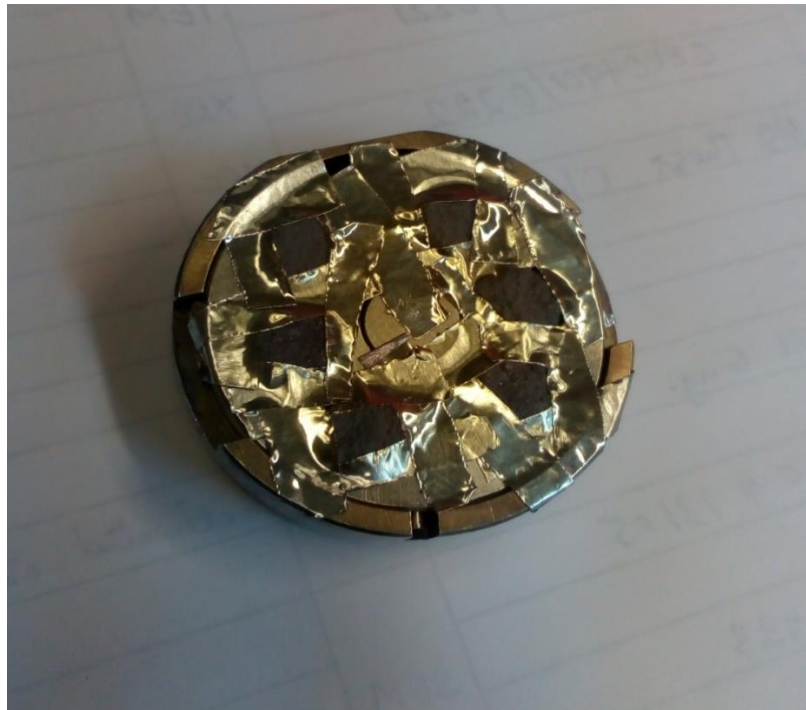
Figure 3-12: Sample holder for SEM
